Minerals Inspection Report

Mine Name: ML 47821&46956/Cubical2	Permit Number: S/023/0057	Mine Status: Active
Operator Name: Mike Sprunger	Inspection Date: 04/09/2014	Permit Fees: Paid
Inspector(s): Wayne Western - Duane Bays	Inspection Time: 12:01 PM - 2:40 PM	Bond Amount: \$5,400
Attendee(s): Mike Sprunger	Weather: Warm and partly cloudy	Bond Escalation: 12/13/2009
Inspection Purpose: Operator request		Prior Inspection: 08/10/2011

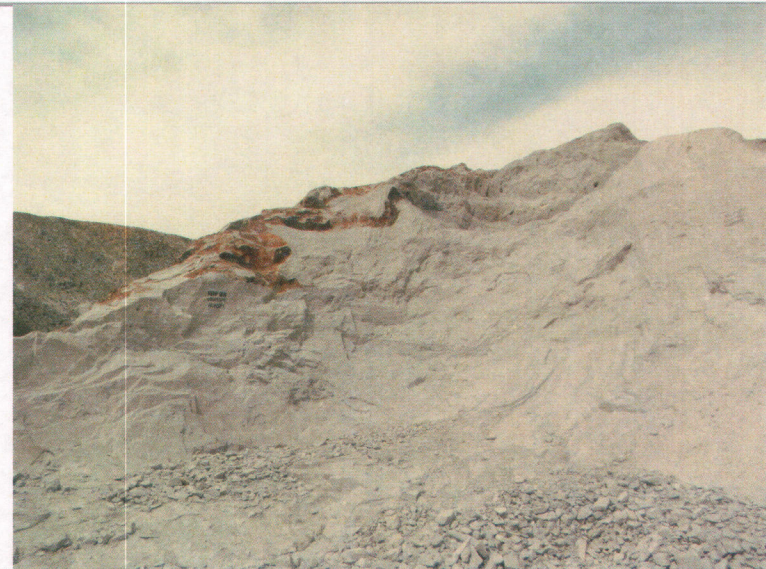
Looking west at northern end of disturbed area on SITLA ground

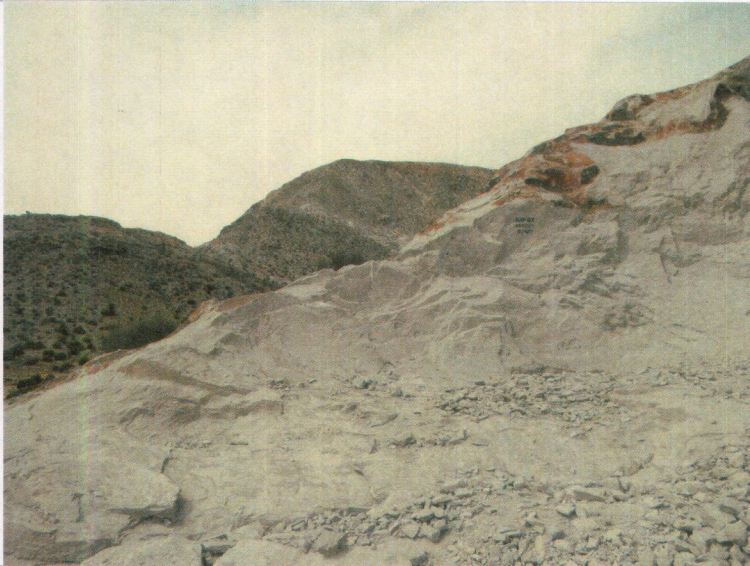
Looking west at southern end of disturbed area

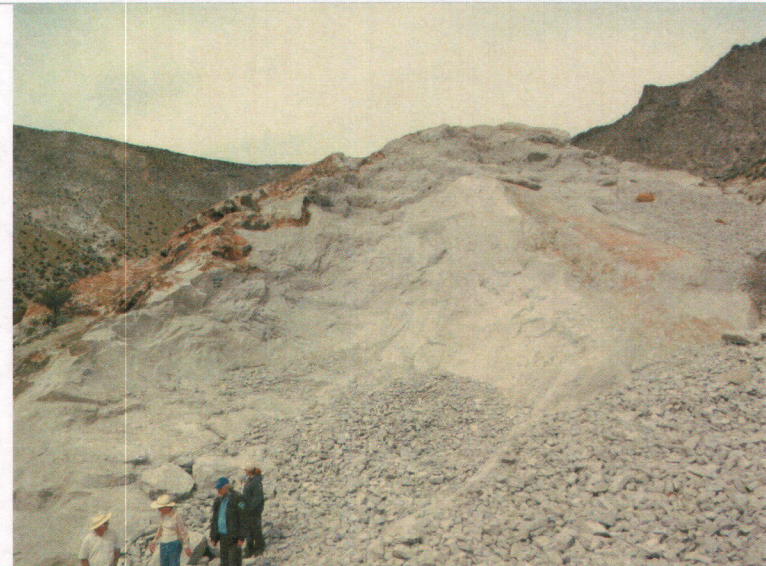
Overview of disturbed area

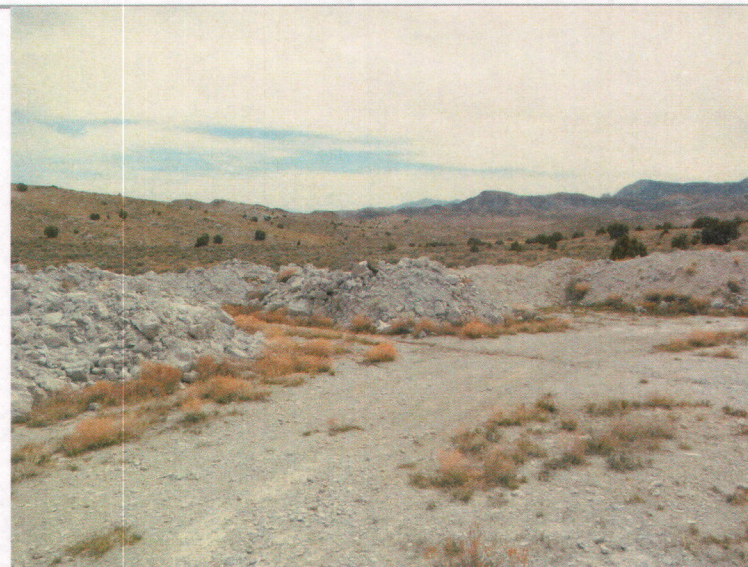
Waste piles

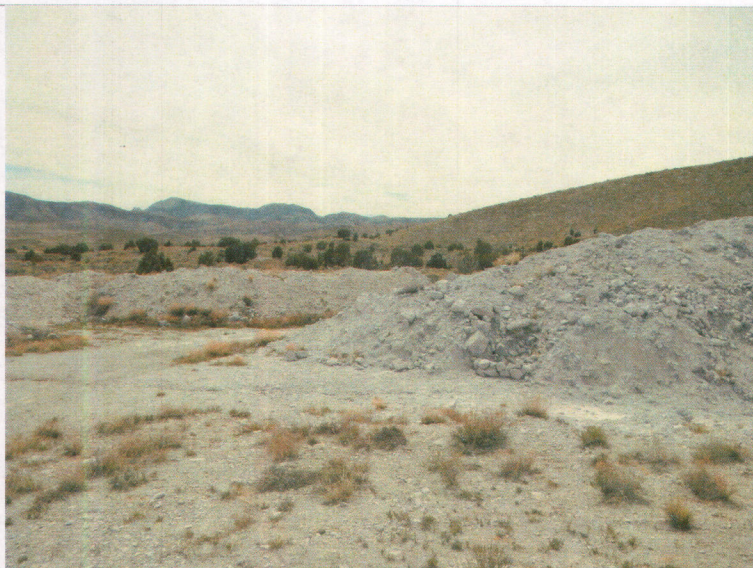
Waste piles

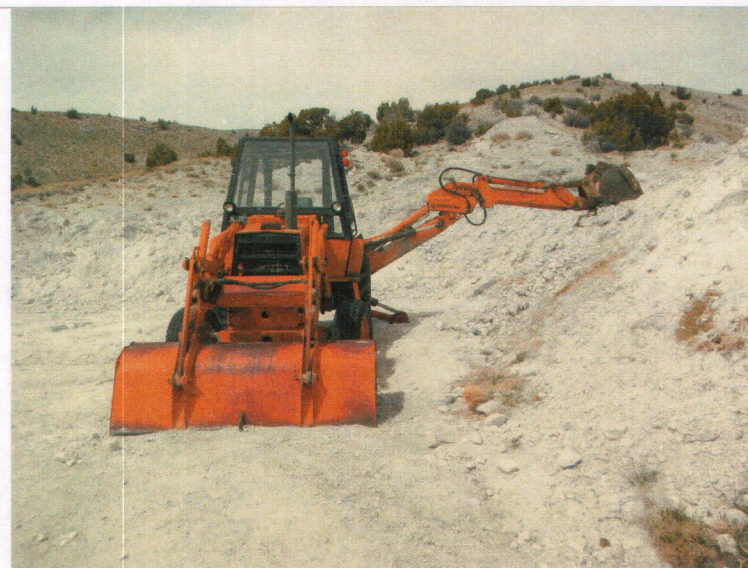
Active area

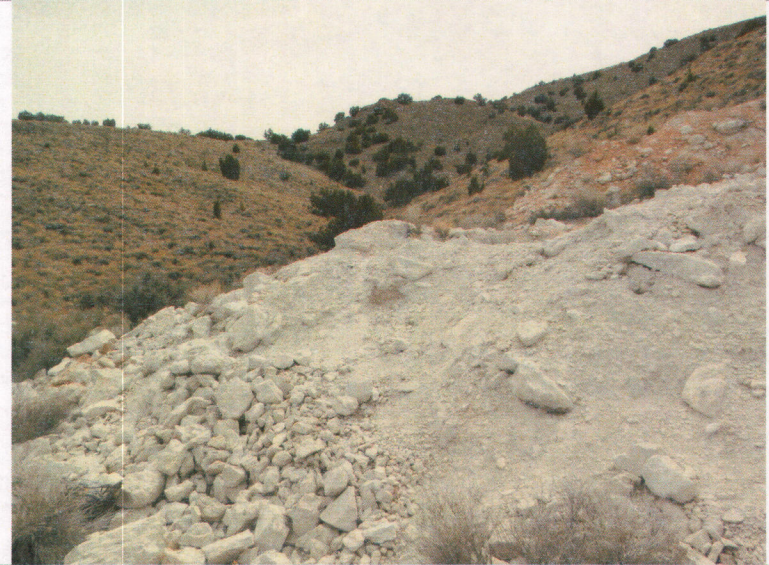
Waste piles

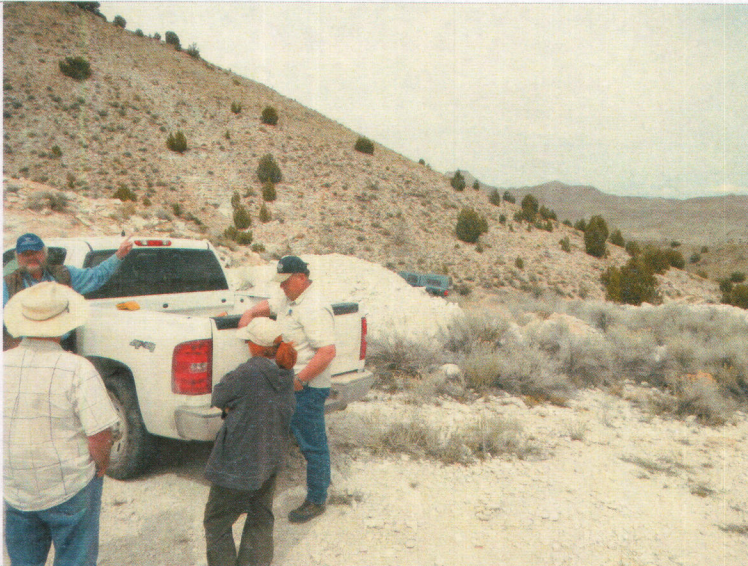
Entrance to site

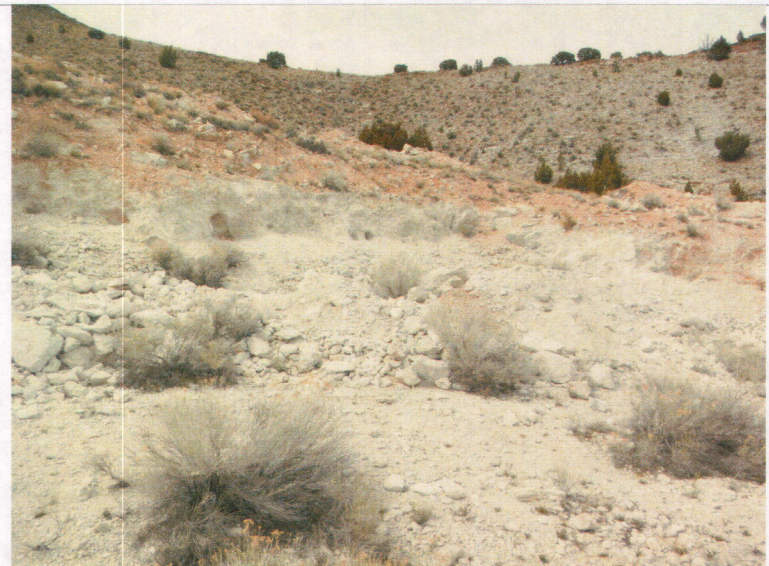
Disturbed area
